PASSAIC RIVER BASIN
ROCKAWAY RIVER & TROY BROOK,
MORRIS COUNTY

NEW JERSEY
BOONTON DAM

PARSIPPANY DIKE

PHASE I INSPECTION REPORT

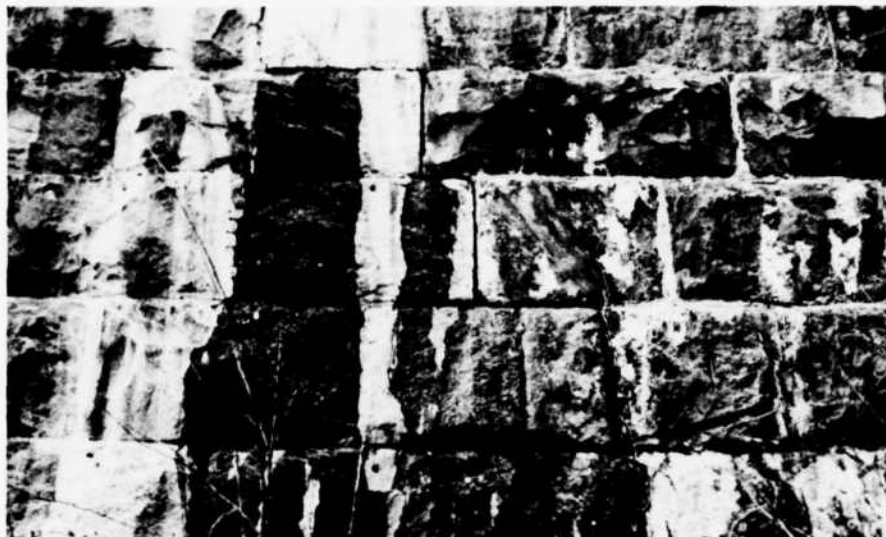
A crack in the jointing was located on the downstream face about 300 feet from the north embankment. Water is seeping from the crack at a rate to keep the stone moist.

CRACK AND SEEPAGE AT NORTH END OF DAM
